# THE ENGINEERING GEOLOGY OF FRANKTON ARM.

A thesis  
submitted in partial fulfilment  
of the requirements for the degree  
of  
Master of Science in Engineering Geology  
in the  
University of Canterbury  
by  
**DEBORAH LOUISE STOSSEL**

University of Canterbury,  
June, 1999.

Seven bedrock landslides situated within quartzofeldspathic schist exist up slope of the residential area along the Frankton Arm of Lake Wakatipu, South Island, New Zealand. Engineering geological and geotechnical failure models for these landslides have been established using engineering geological mapping at scales of 1:5000 and 1:10000, geotechnical testing, and the development of limit-equilibrium sensitivity models.

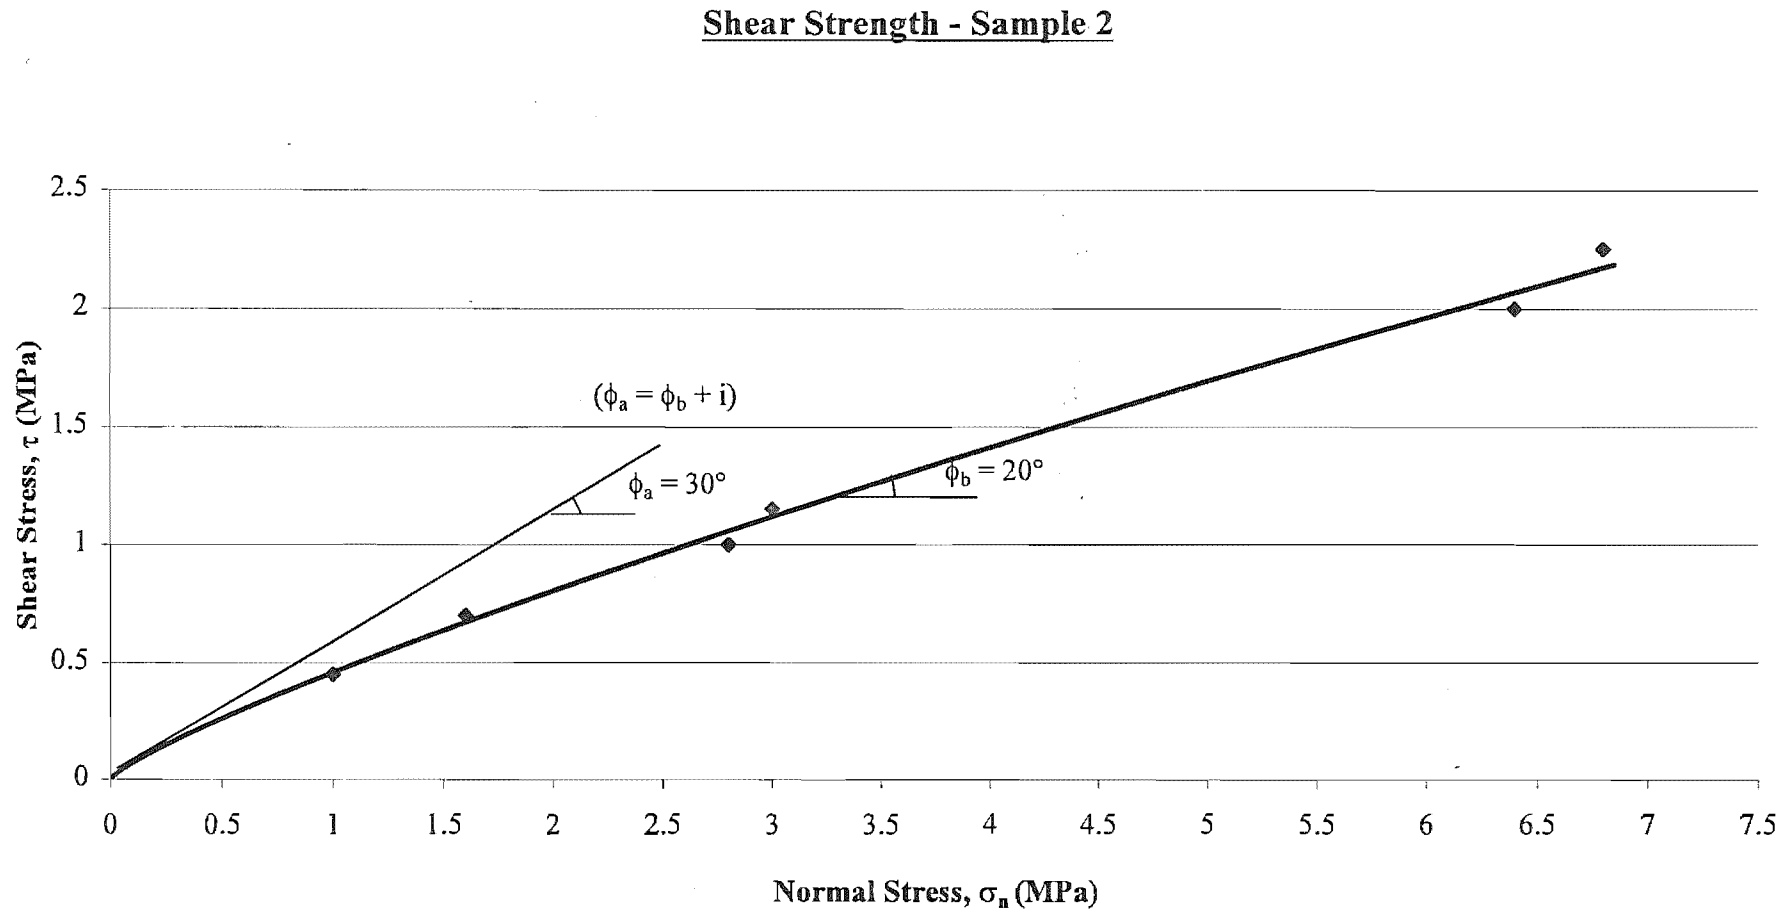
Figure 3.1: Graph of shear strength versus normal stress for Sample 2 (an artificially fractured schist block).

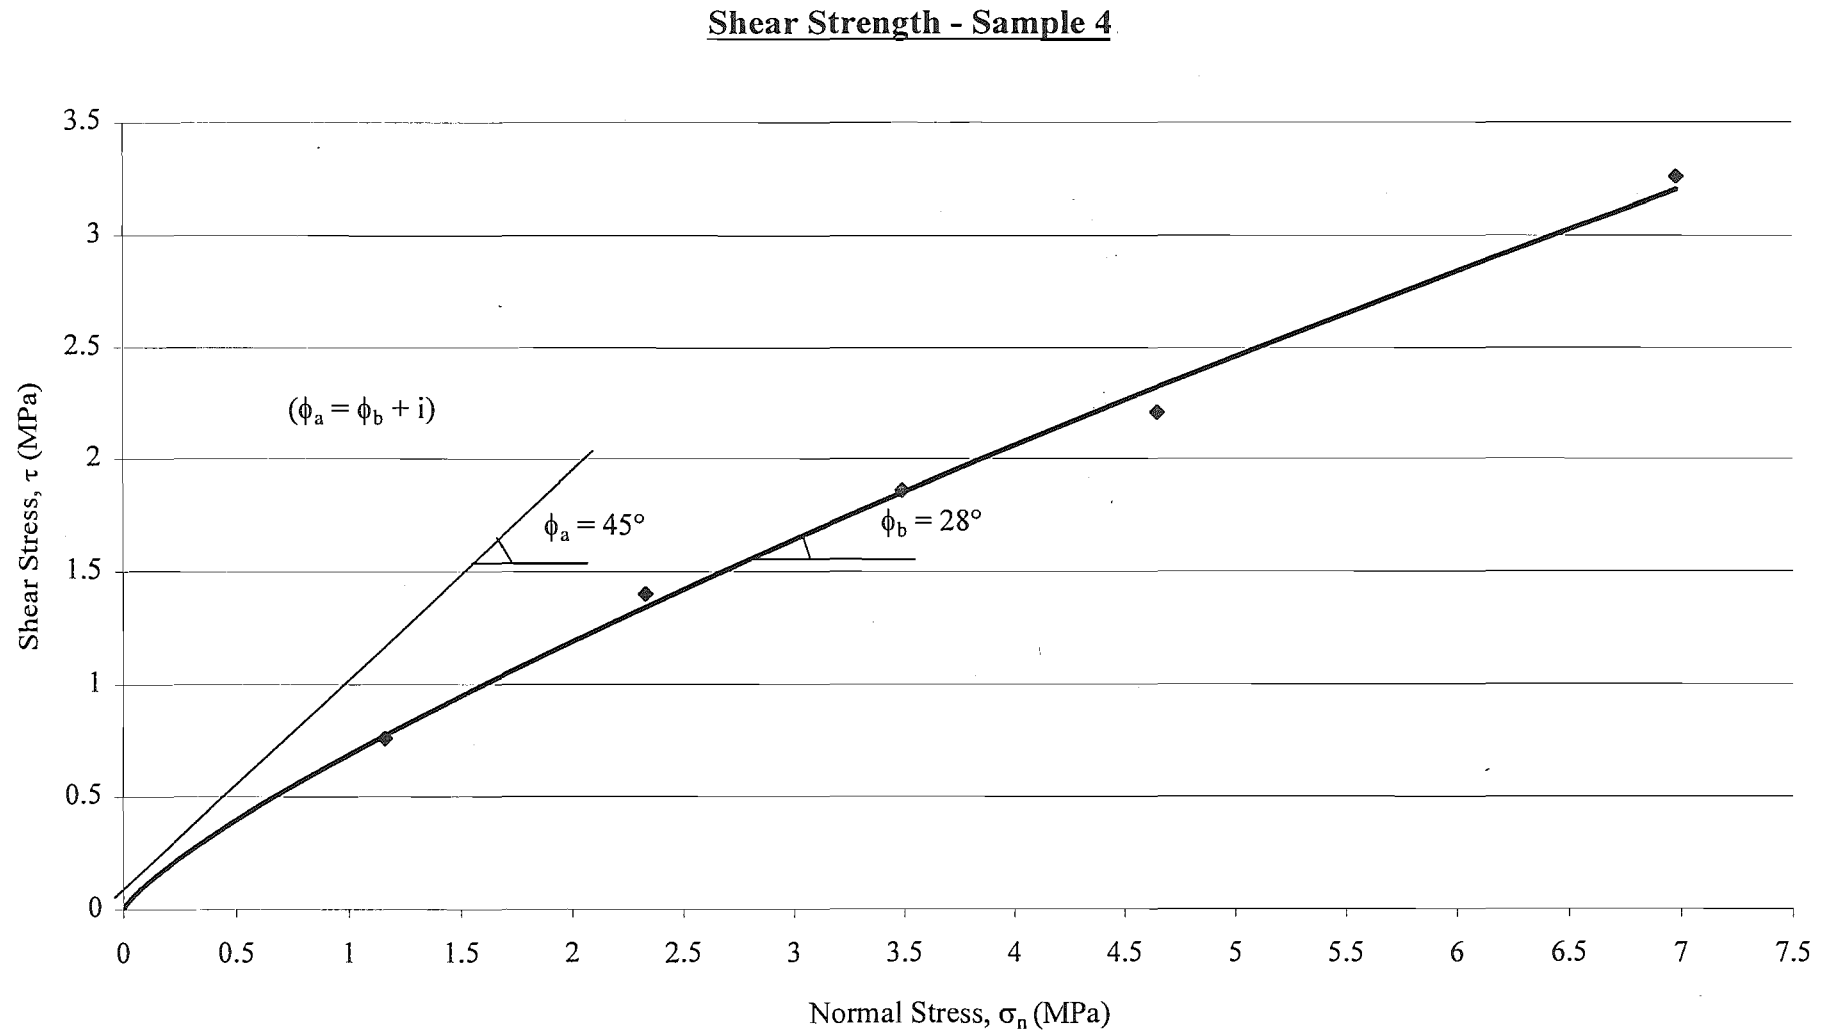
Figure 3.2: Graph of shear strength versus normal stress for Sample 4 (an artificially fractured schist block).

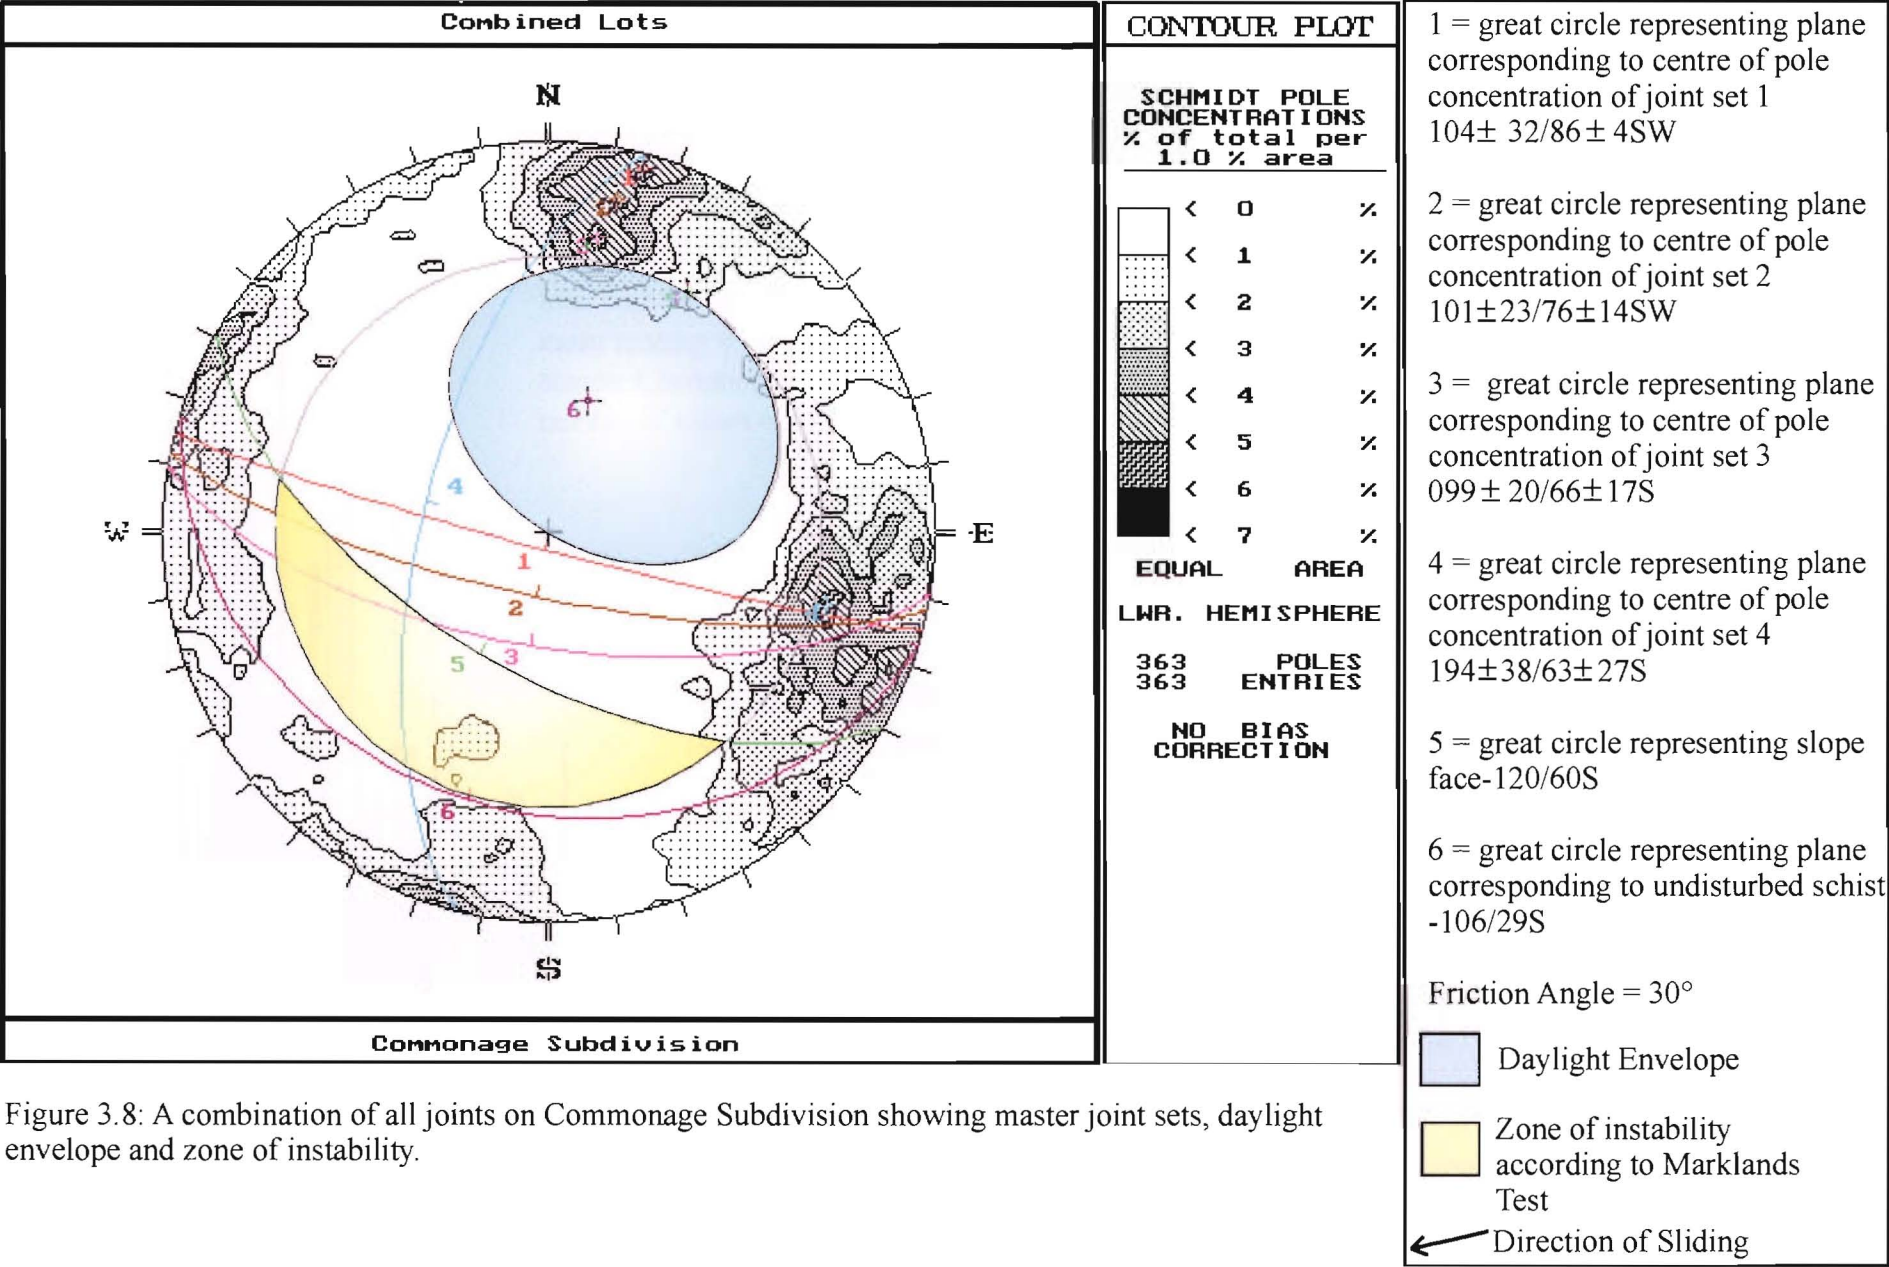
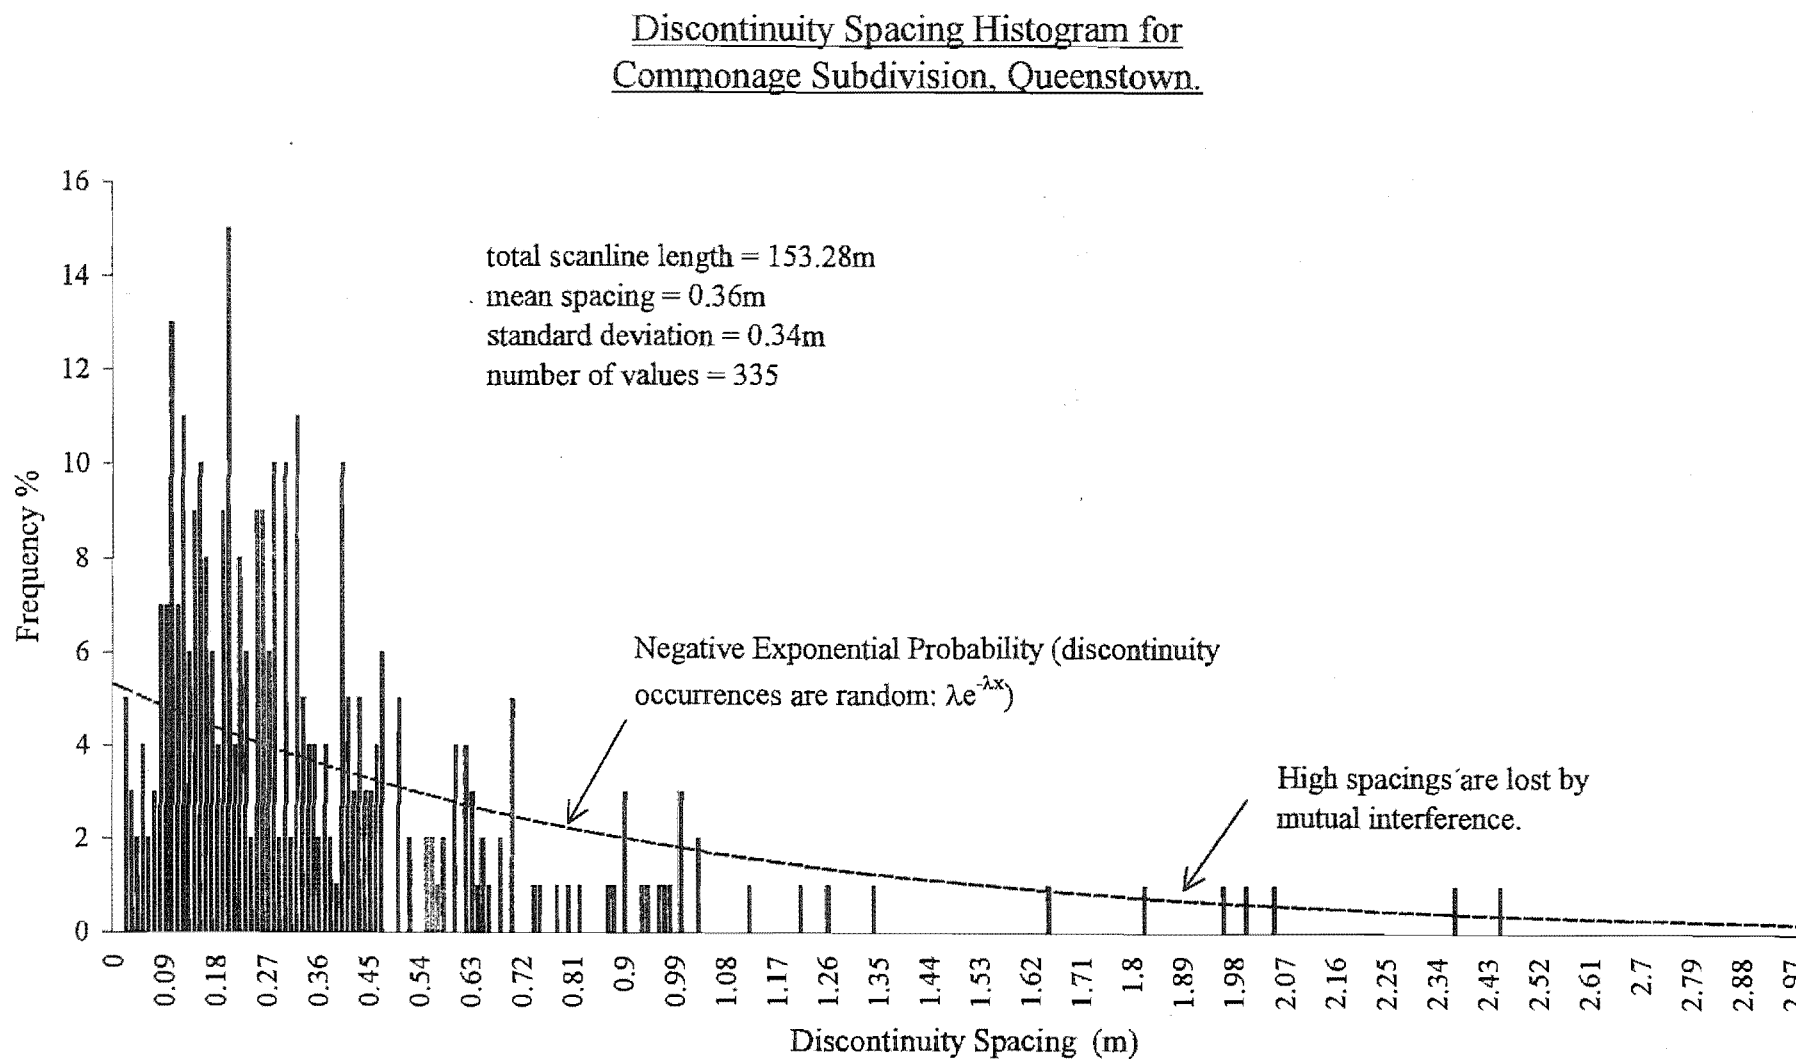
Figure 3.9: Histogram of discontinuity spacings for the Commonage Subdivision, Queenstown.

A histogram of discontinuity spacings for the Commonage Subdivision is given in Figure 3.9. Priest (1993) defines discontinuity spacing as the distance between a pair of discontinuities measured along a line of specified location and orientation. Figure 3.9 is of total spacing – the spacing between a pair of immediately adjacent discontinuities. The mean discontinuity spacing provides a direct measure of rock quality, and a histogram plot provides a good illustration of the distribution of defect spacing. Figure 3.9 shows a negative exponential

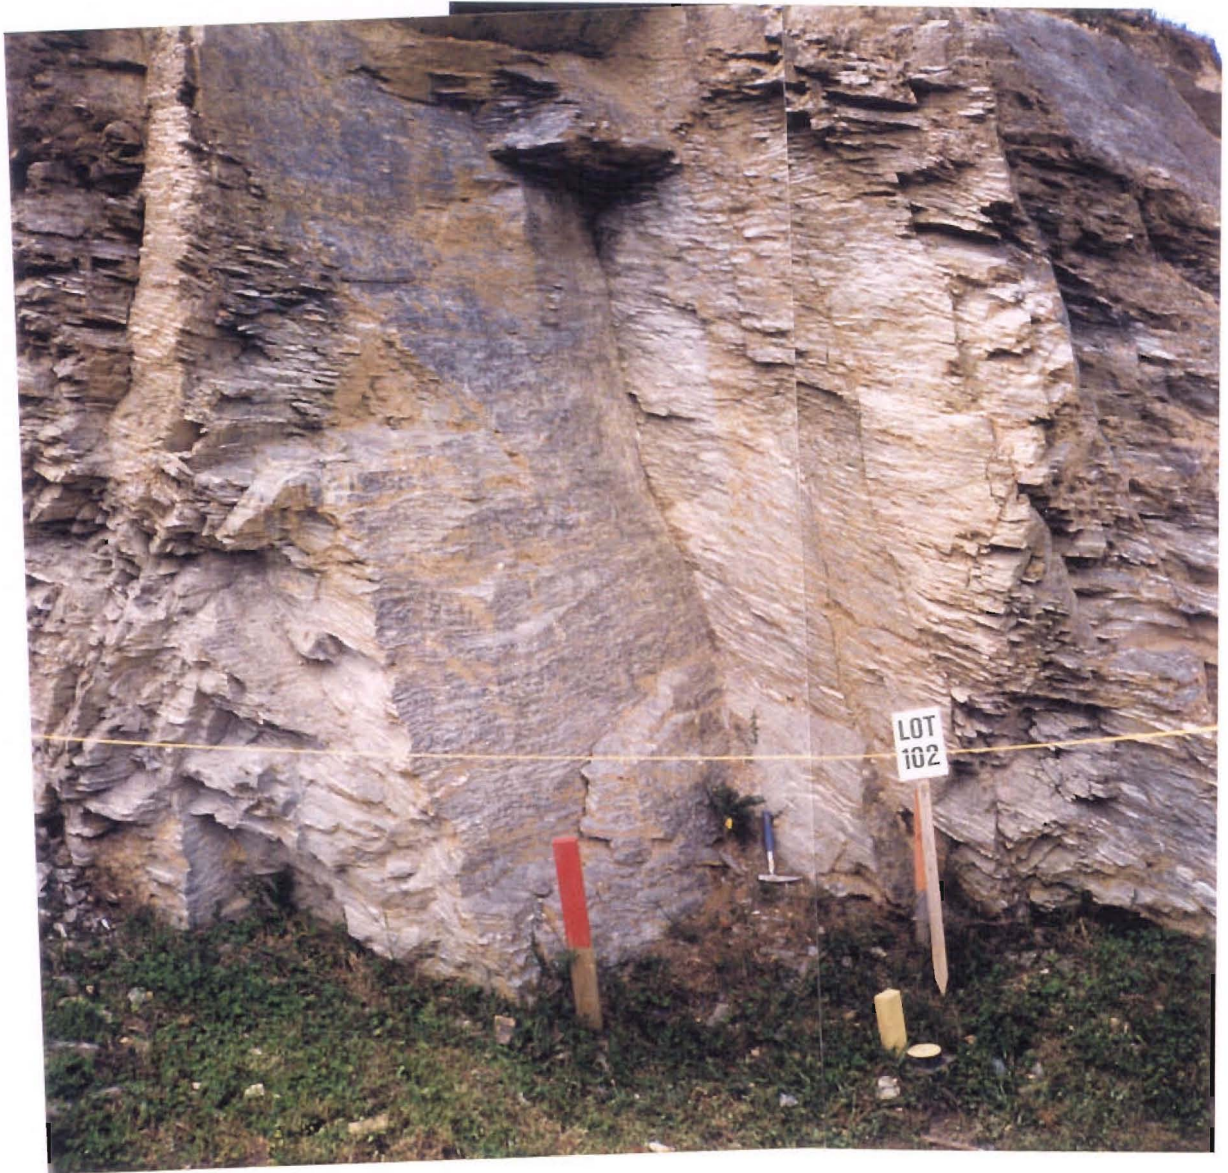
Figure 3.11: A wedge failure (a consequence of blasting) that may not have taken place under natural conditions as the intersection of the two faces (directly above the hammer) is dipping too steeply. A classic small wedge failure has occurred in the top centre, a result of the removal of support of the underlying schist blocks. The intersection between these two planes has a much shallower dip, thus would have occurred naturally.

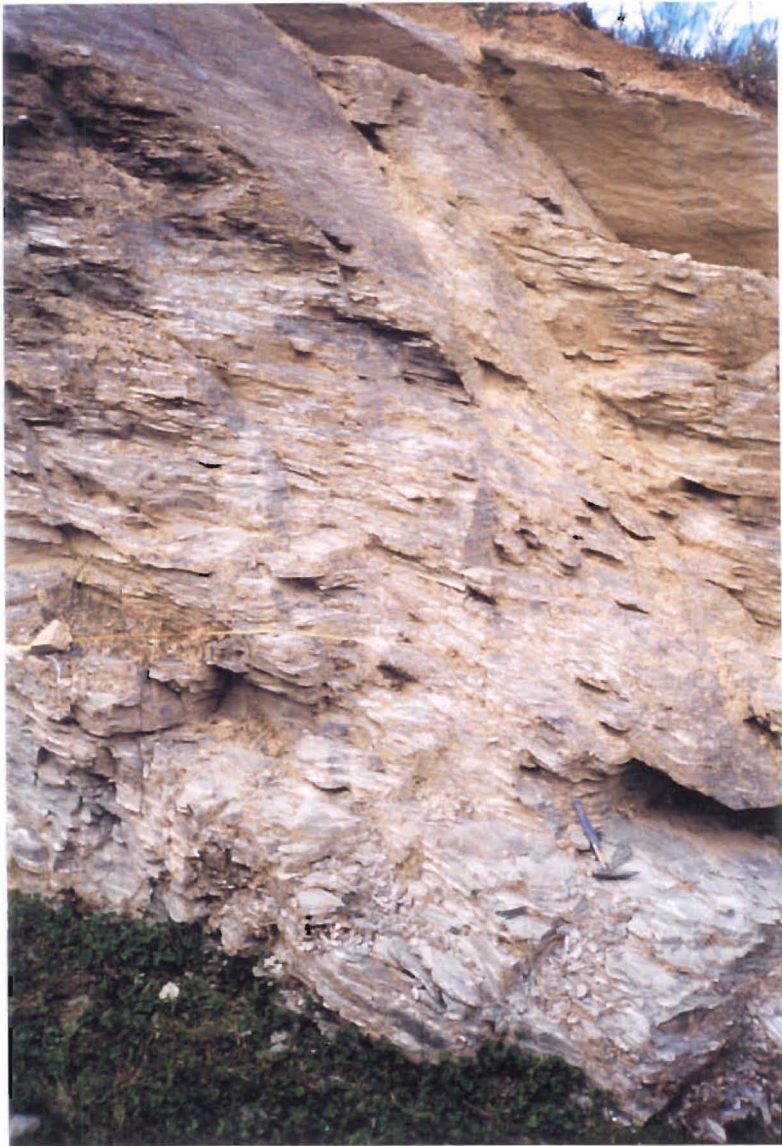
Figure 3.12: Ravelling of minor schist blocks (immediate right of the hammer), which may continue if left unsupported, and result in the formation of larger wedge-type failures.

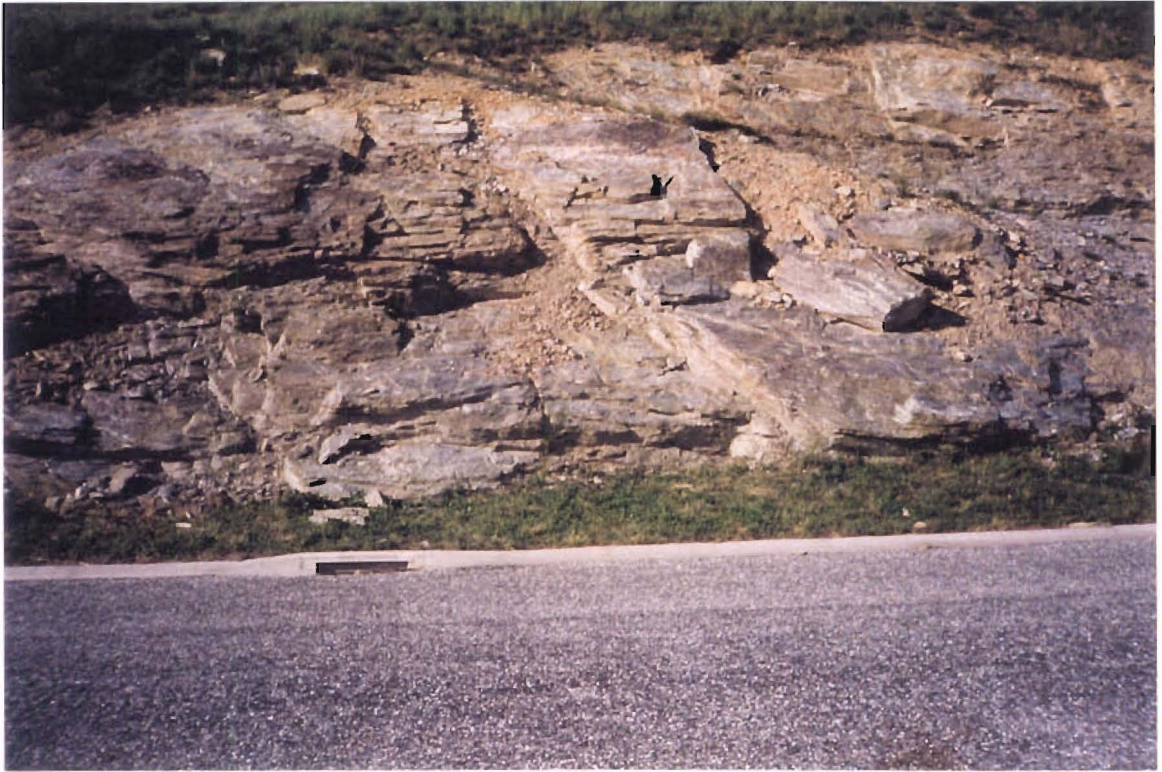
Figure 3.13: A series of sub-vertically dipping joints which have acted as releasing surfaces for simple translational planar sliding parallel to the foliation.

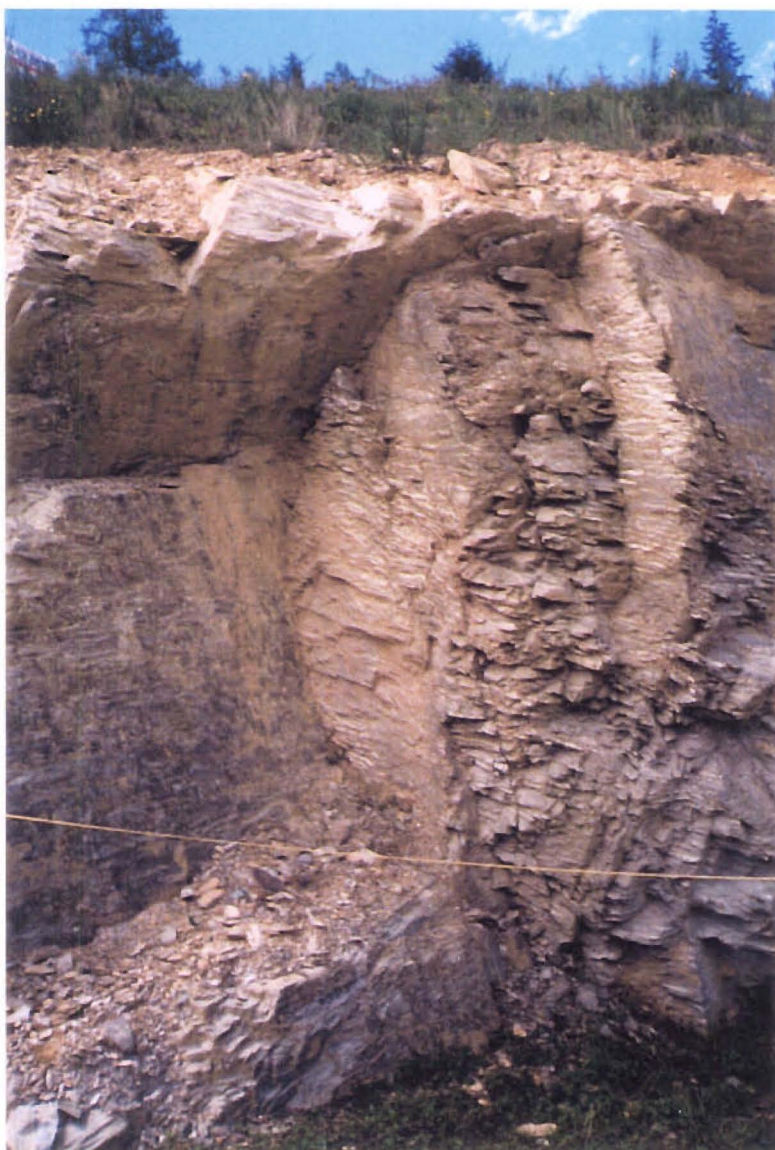
Figure 3.14: Unravelling and undermining of the rock face has left the overlying rock unsupported. A small wedge failure has resulted in the top left of the photo. The intersection between the two planes of the wedge failure has a shallow dip (out of the slope) and has subsequently failed (towards the viewer).

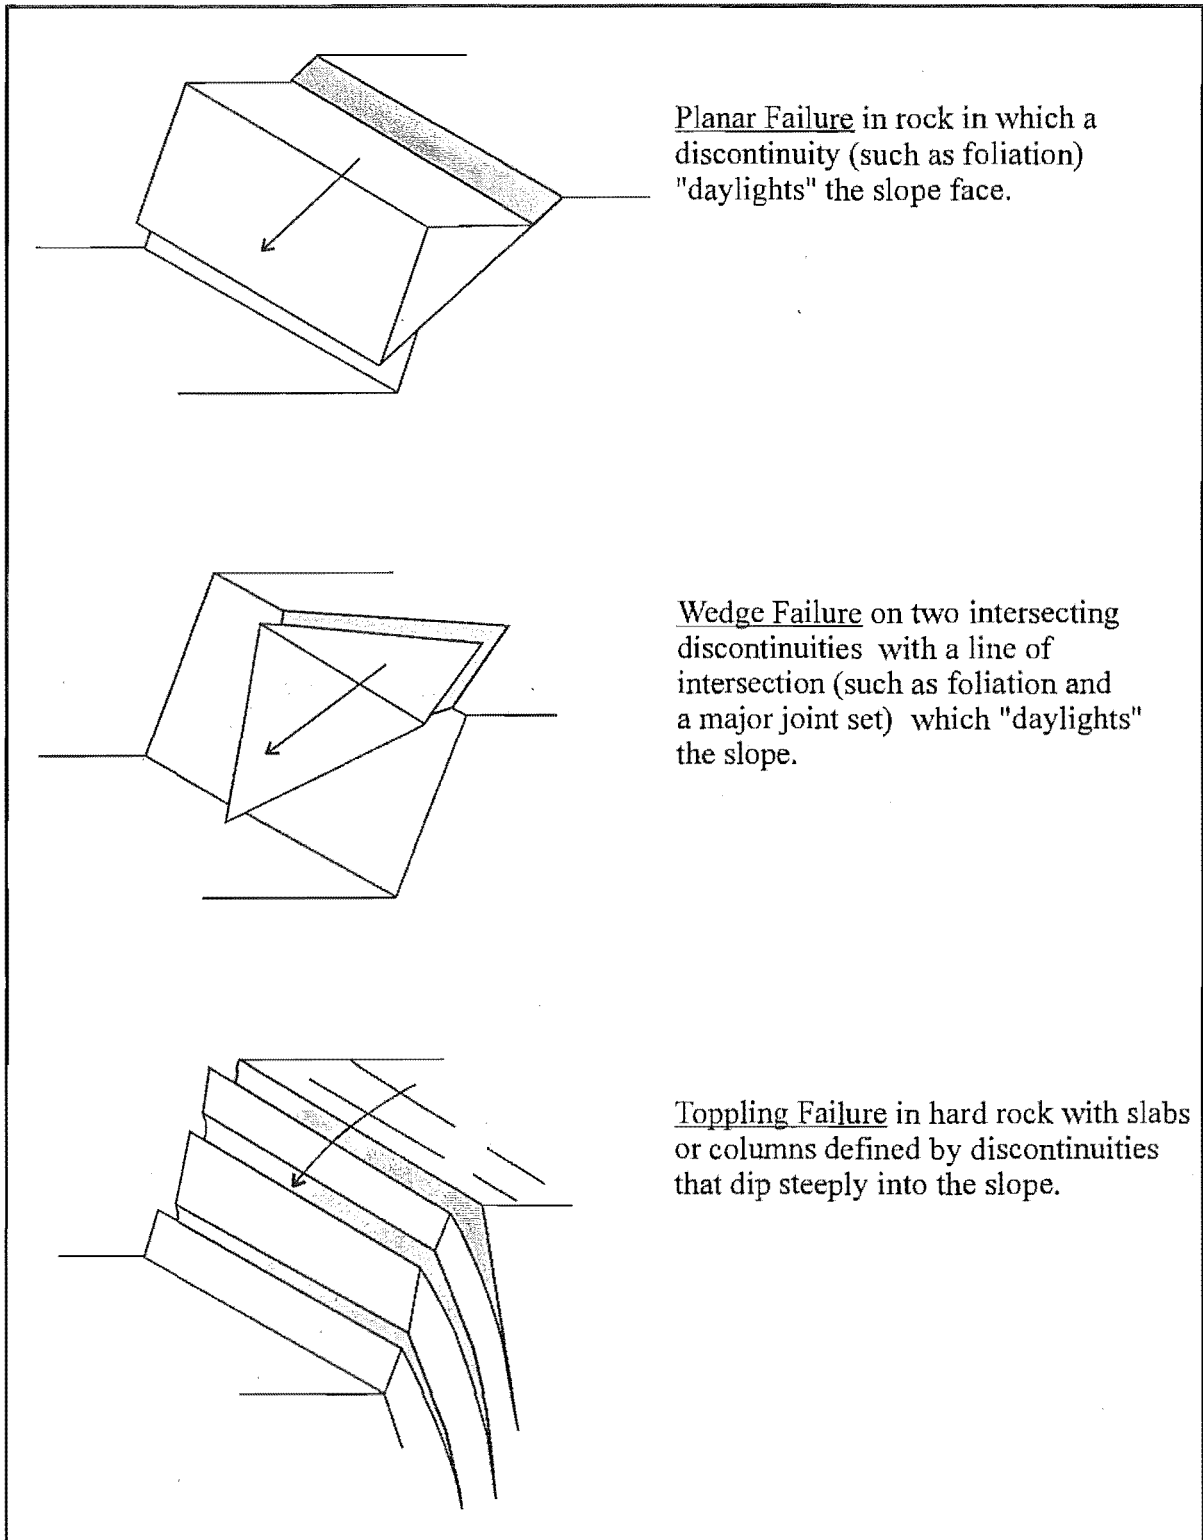
Figure 4.1: Types of rock slope failures in schist terrain (from Hoek and Bray, 1981; and Norrish and Wyllie, 1996).

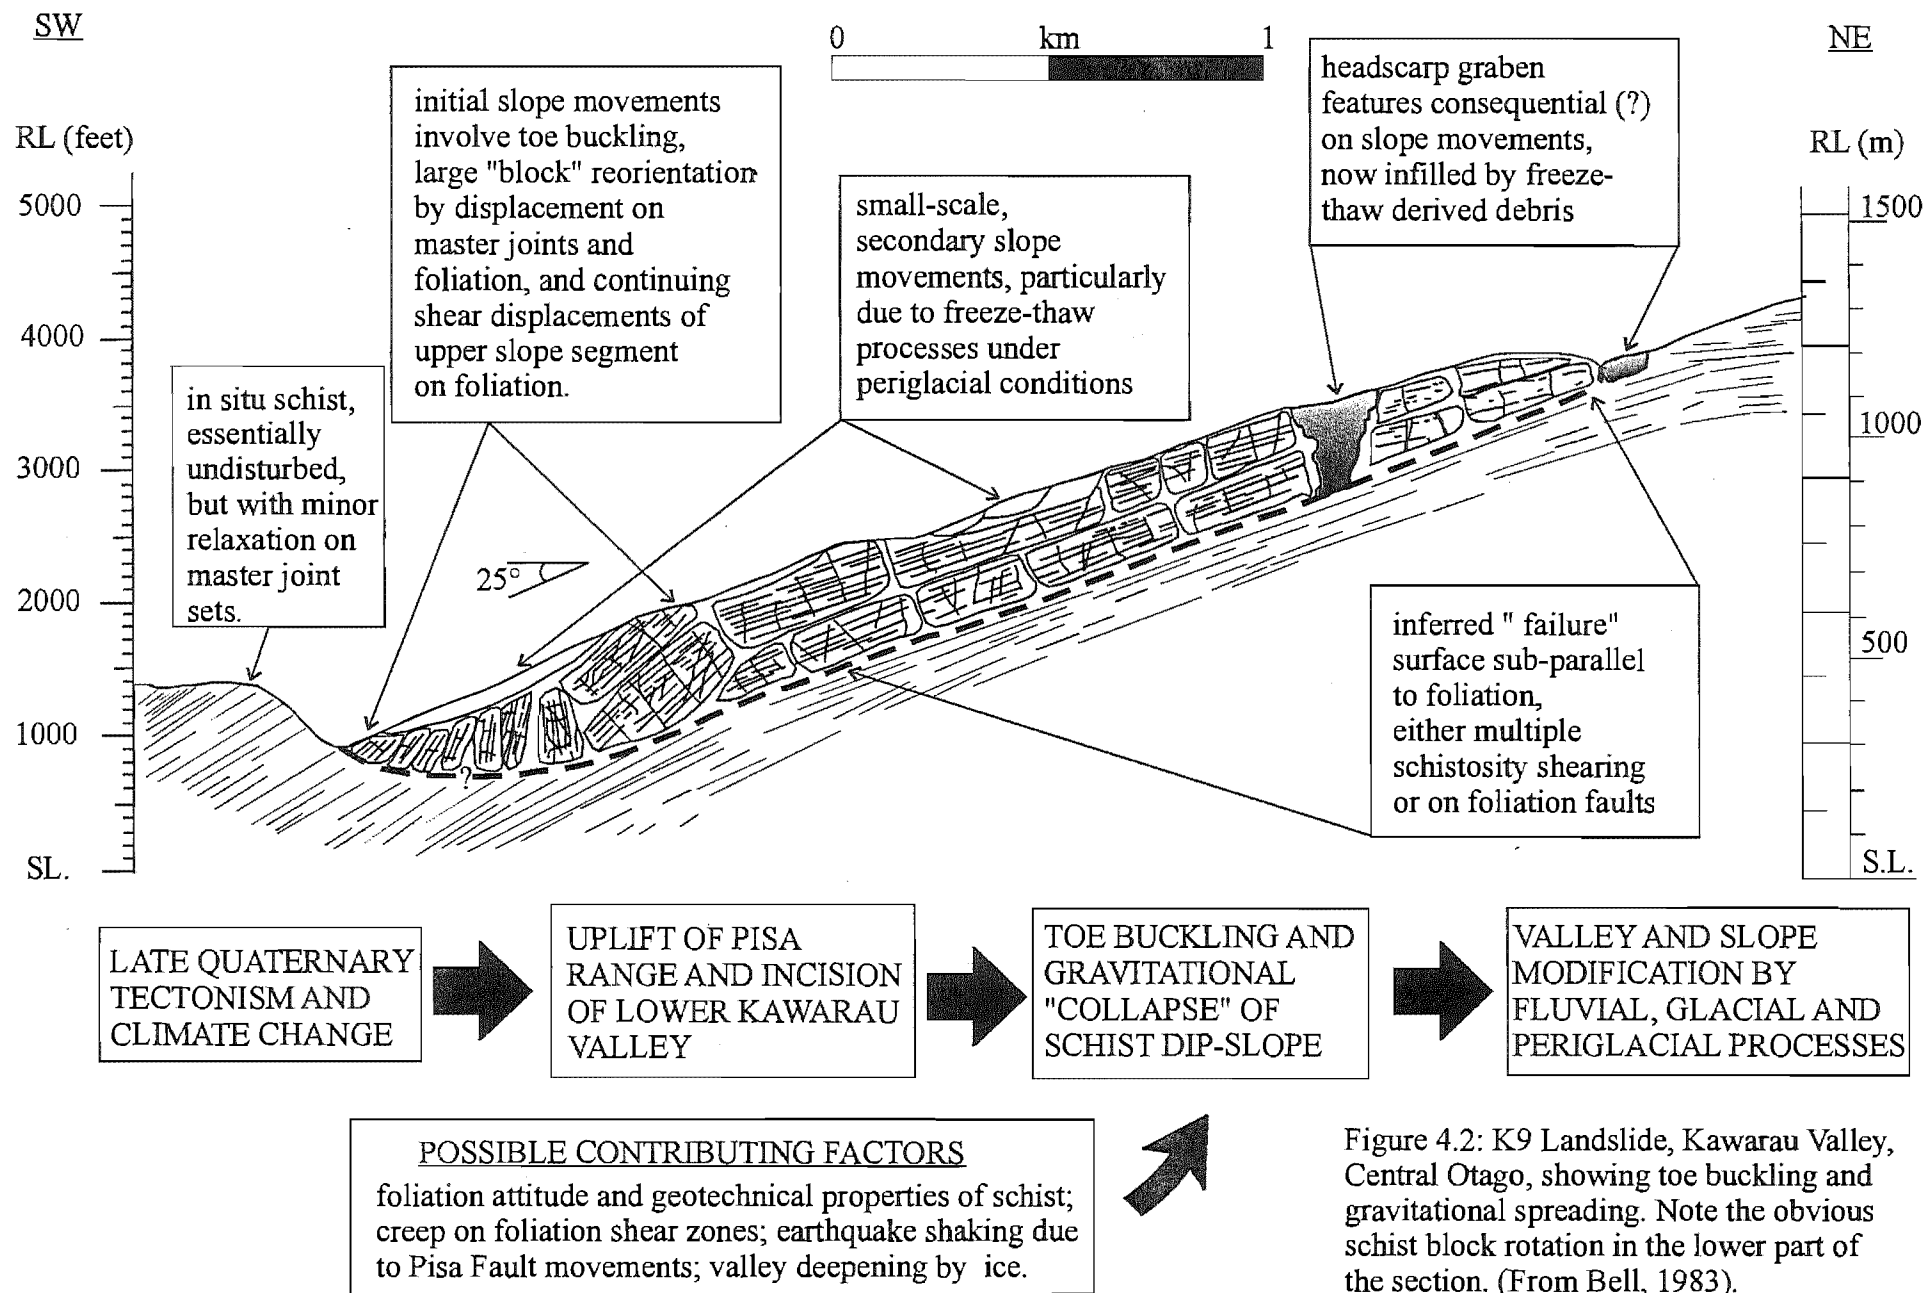
Figure 4.2: K9 Landslide, Kawarau Valley, Central Otago, showing toe buckling and gravitational spreading. Note the obvious schist block rotation in the lower part of the section. (From Bell, 1983).

The evidence for both toe “buckling” and gravitational “spreading” in the K9 Landslide is summarised in figure 4.2. Buckling of the toe and partial over-riding by displaced blocks from up slope is represented by schist block rotation. Graben features have developed as a result of toe “buckling” and rock mass displacements of possibly as much as 100m, and have

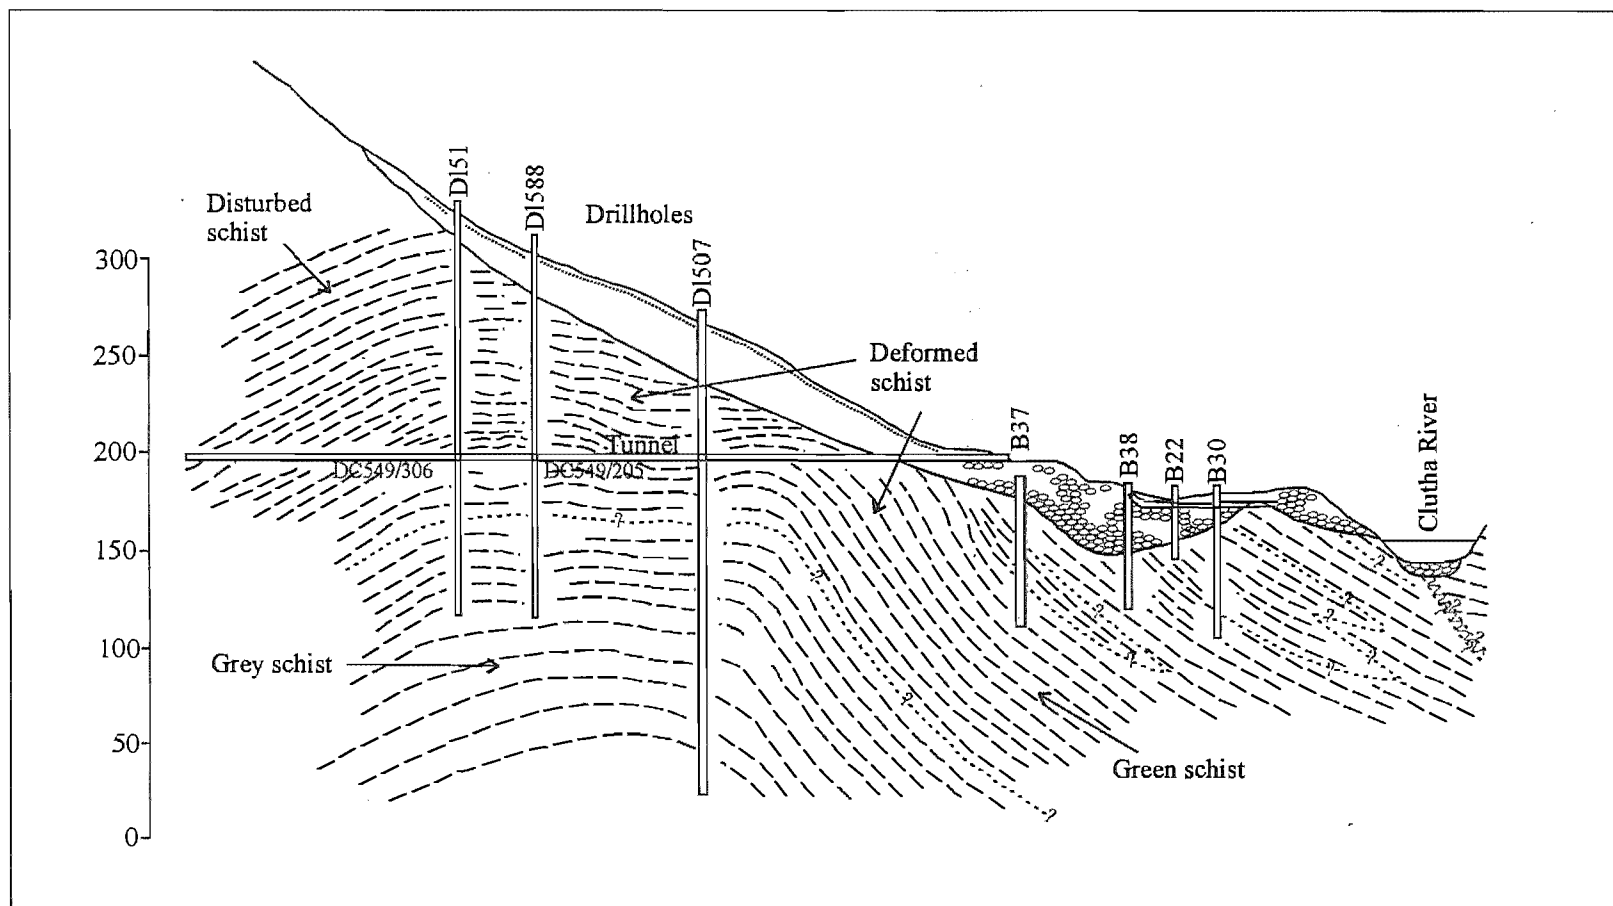
Figure 4.3: An example of toe buckling deformation without development of a basal failure zone in the mid Nine Mile Landslide area, Cromwell. Subsurface evidence indicates the schist is folded into an upstream plunging, gentle antiform structure (interlimb angle  $140^\circ$ ) which has been later deformed by toe buckling in the near-surface zone (0-100m depth, so that the hinge and downslope limb have been oversteepened to form an accentuated, asymmetric fold (interlimb angle  $90^\circ$ ). (Redrawn after Beetham et. al., 1991).
